**PAGE COUNTY  
JAIL STUDY  
OCTOBER 19, 2021**

## INTRODUCTION

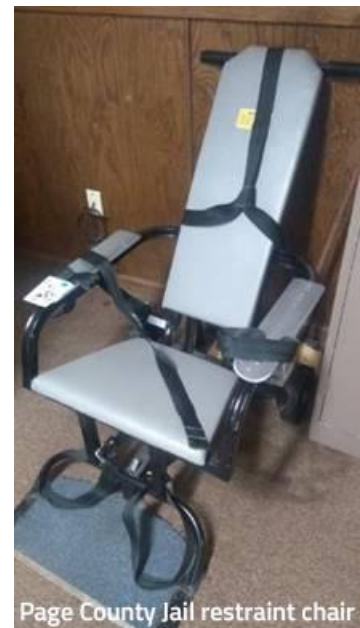
The existing facility does not have a safety (padded) cell similar to the example image to the right. Additionally, the existing Jail does not have the ability to have a proper medical isolation or quarantine cell. These types of safety or isolation cells are becoming more important to jails as mental health problems become more common. Mental health is expected to become a much greater problem for the Page County Sheriff's Department and Jail due to the recent reduction in funding for mental health facilities in Iowa. When hospitals or other mental health facilities are not able to treat the individuals, they often end up in Jail. These types of cells help to protect the inmate from injuring themselves and surrounding inmates and staff. The only tool Page County Jail Staff have at their disposal to help protect themselves and the inmate from injuring themselves is an old, modified restraint chair that is shown to the right.

Page County Jail restraint chair

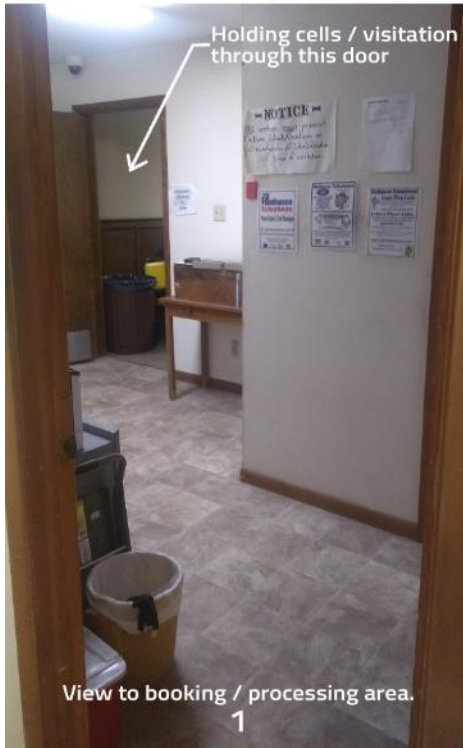
Holding cells / visitation through this door

View to booking / processing area.  
1

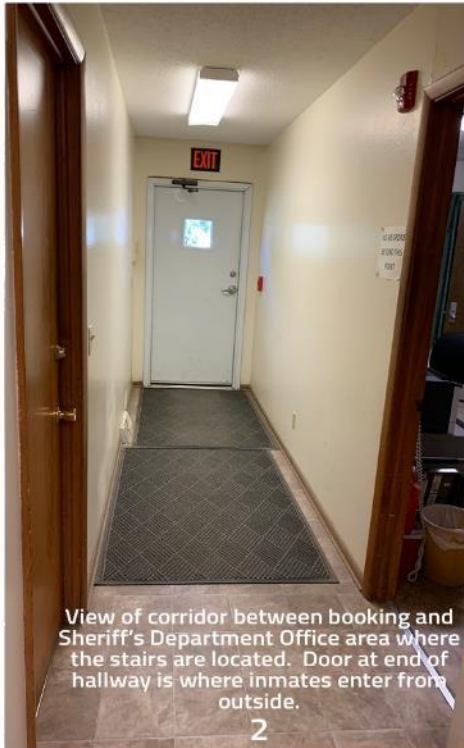
View of corridor between booking and Sheriff's Department Office area where the stairs are located. Door at end of hallway is where inmates enter from outside.  
2

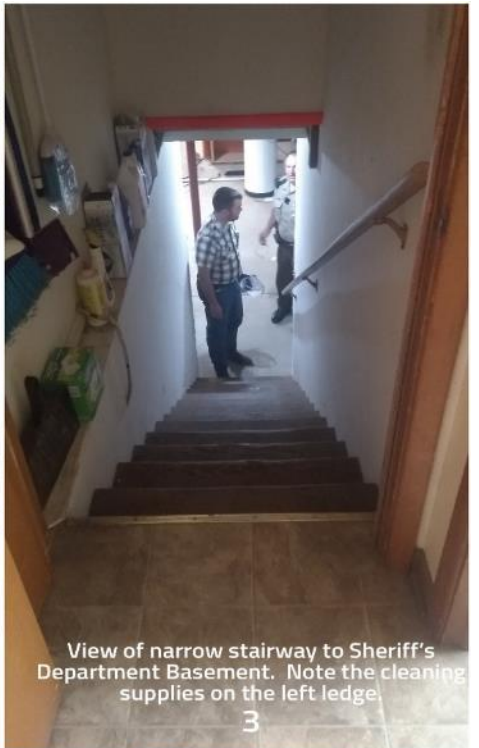
View of narrow stairway to Sheriff's Department Basement. Note the cleaning supplies on the left ledge.  
3

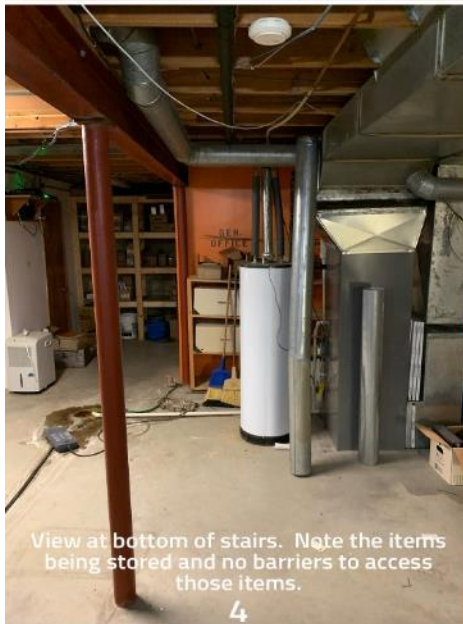
View at bottom of stairs. Note the items being stored and no barriers to access those items.  
4

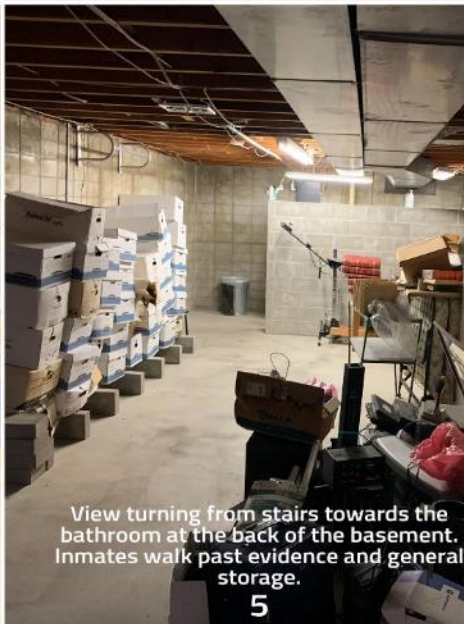
View turning from stairs towards the bathroom at the back of the basement. Inmates walk past evidence and general storage.  
5

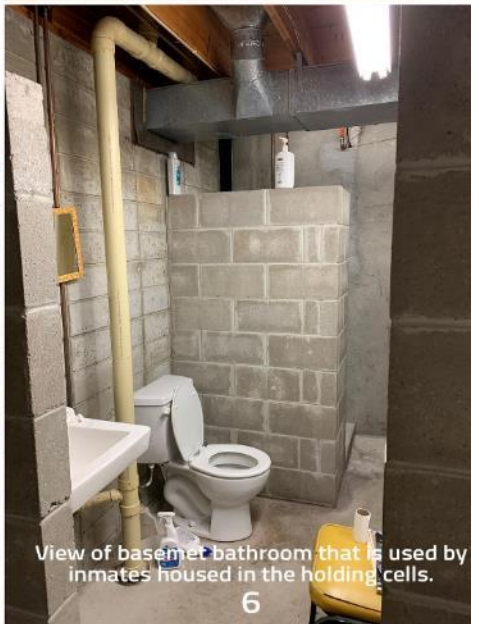
View of basement bathroom that is used by inmates housed in the holding cells.  
6

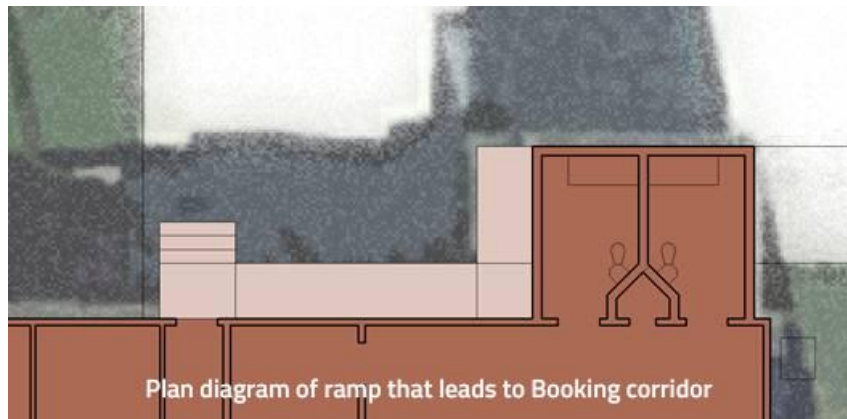
The main entrance to the Sheriff's Department on the west side of the building is not ADA accessible as there are steps to enter the building rather than a ramp or being at grade. A wood framed ramp with covering was added to the north side of the building at the inmate processing entrance. While this provides accessibility to the first floor of the Sheriff's Department and Jail, it is within the secured area of the Sheriff's Department Office, but is outside of the secured Jail area.

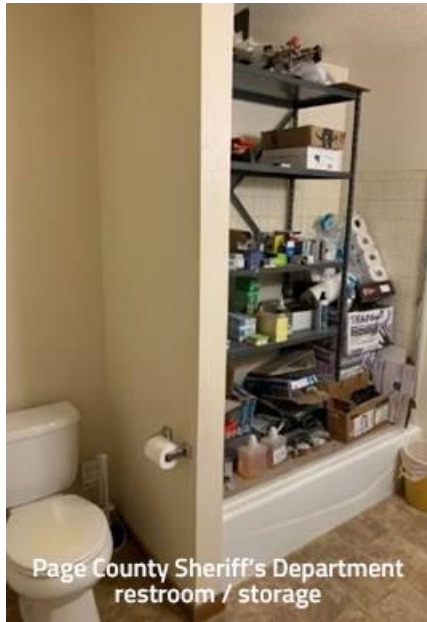
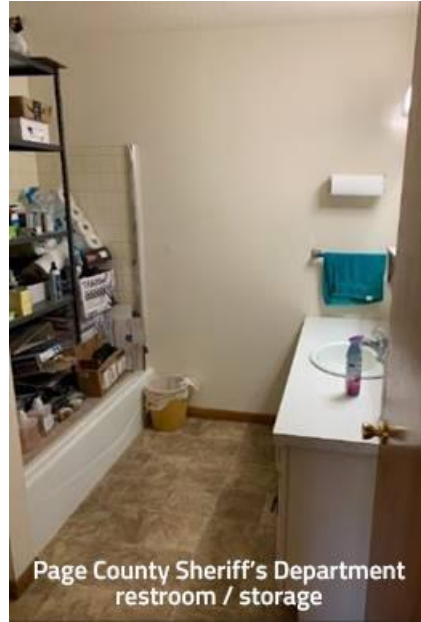
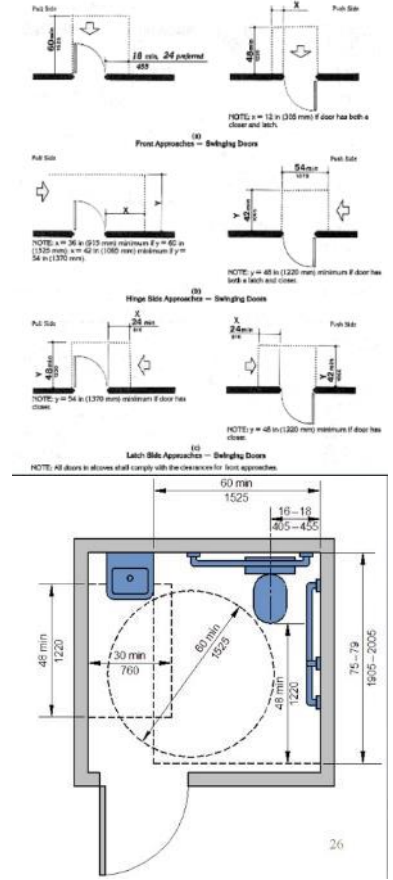
There are several doors throughout the facility without the proper maneuvering clearances. ADA Standards require a 12" to 18" clearance at the side of the doors and between 42" and 60" in front of the door depending on whether it is on the push/pull side, if the door has a closer or not, and how a person approaches the door.

The Sheriff's Department Office Toilet Room is not currently accessible due to dimensional clearances or additional features such as toilet grab bars.

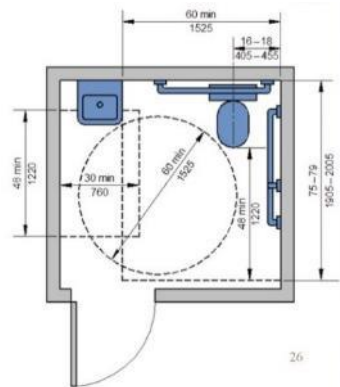
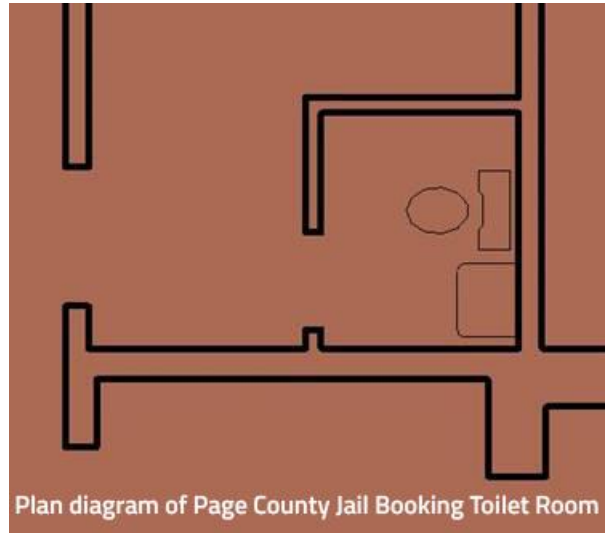
The toilet room in Booking/Processing is not ADA accessible due to insufficient dimensional clearances and other features. Since this toilet room is intended to be used only by inmates being processed for security reasons, it should be accessible.

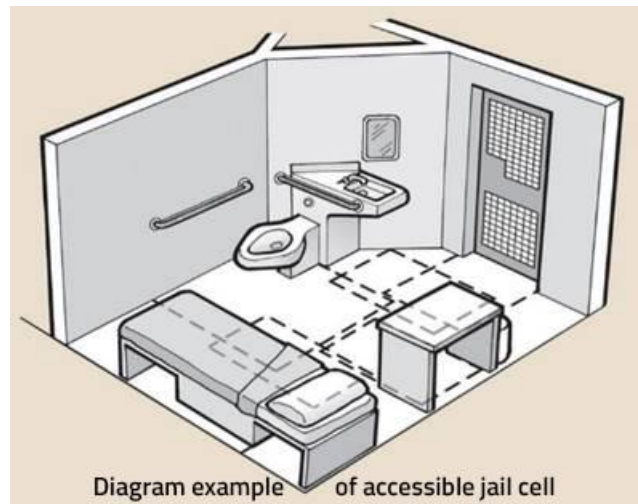
Throughout the main dorms and cells of the Jail, there are many additional ADA Standards which are not being met such as accessible cells, accessible furnishings, accessible restrooms and additional features. This is mostly due to the physical layout and construction of the facility. Some of the ADA standards that apply to jails include: at least 5% of beds in dorms of 25 or more have clear floor space by the beds, at least 3% of the cells must be accessible for individuals with mobility disabilities, accessible cells must be provide within each classification level as well, 2% of the general holding cells to be equipped with communication features (phones, visual alarm signals, etc..) that allow deaf or hard of hearing individuals the ability to communicate, 32" minimum door clear widths, turning radiuses accommodated, accessible showers provided, among others.

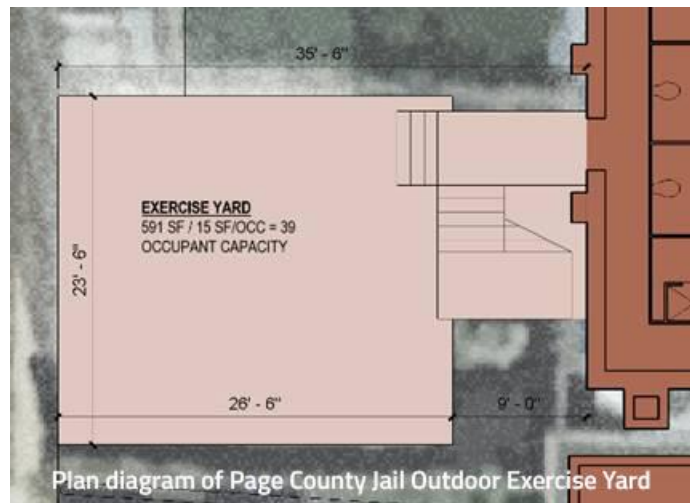
One requirement of the IBC is in regard to what is called Exit Discharge. Exit Discharge means the open area on the outside of the building where people can safely gather when leaving a building emergency. IBC Section 408.3.6 states that the Exit Discharge for I-3 facilities shall not be less than 50 feet from the building, have capacity for a minimum of 15 square feet per occupant and can be in an enclosed yard or court. The fenced in exterior Exercise Yard is the only secured area on the exterior of the Jail but does not meet the 50-foot separation requirement from the building. This space could meet the IBC requirement for the 35 inmates that the facility is rated for if it was located 50 feet from the building.

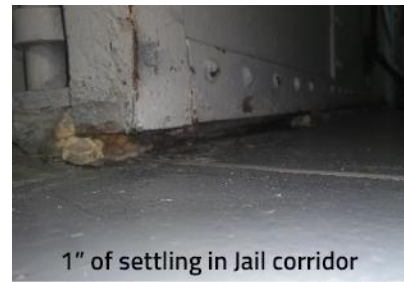
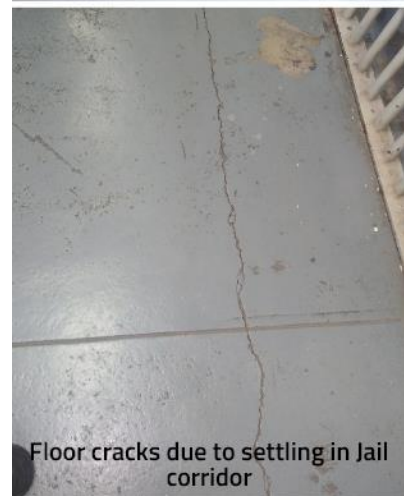
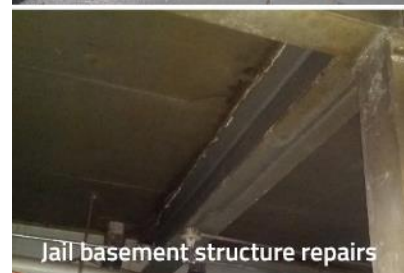
There are signs of building movement between the floors of the building within the Jail portion which have resulted in cracks and sloping in the concrete slab floors. This building movement has caused floors to slope and drop nearly an inch in some places. In 2018, Page County Jail was required by the Iowa Department of Corrections Jail Inspection to undergo an evaluation and potential repair of this issue. That report also indicated that the building had approximately 5 years of life expectancy left due to the structural problems of the facility. Though the problem appeared to be resolved for the time being, continual observation of this issue is critical as it could show signs of additional problems. It is not uncommon for older buildings, especially ones constructed of heavy poured concrete to have settling issues as decades pass due to soil and foundation issues under the buildings. Poured concrete buildings can have structural issues with cracks and settling, but if they are monitored and repaired those issues can be resolved so that the building can continue to have a useful life but can be expensive repairs. It is also important to note that concrete can have small hairline cracks that do not necessarily mean there is a structural problem, it could be related to the natural curing process that concrete goes through.

**Comment:** The structural integrity of the Page County Jail appears to be deteriorating. Cracks, separations, sloping floors, and plumbing issues are present and need to reviewed by a professional engineering firm.

**Corrective action:** Page County shall contract with a professional engineering firm with expertise in buildings to determine structural integrity, and to provide a recommended plan of corrective action. A copy of the engineer report and a plan of corrective action shall be forwarded to Iowa Department of Corrections, 510 E. 12<sup>th</sup> St., Des Moines, Iowa 50319 no later than August 13, 2018.

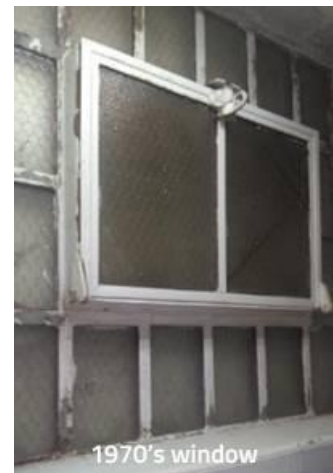
The Jail windows are metal frames, single pane glass with metal mesh and have a translucent finished glass in the windows to prevent views in and out. The windows also have steel bars at the exterior for security reasons. There appears to be rust on the windows and the paint is peeling in many places. These windows do not let quality light enter the building and are not energy efficient.

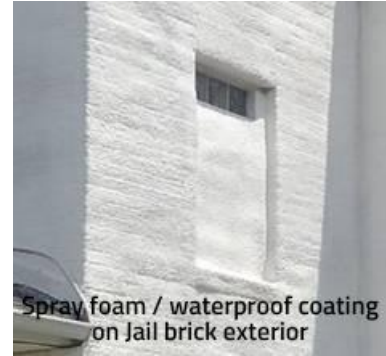
In the past there had been many reports of and observed water leaks in the roof. Those water leaks have stopped after the County hired a contractor to use a closed cell spray foam covering with a waterproof paint over the existing roof. This coating assembly can conform to the arched roof and unique transitions. A very thin layer of this same assembly/coating was applied to the exterior brick walls of the Jail soon after. The closed cell spray foam and waterproof coating should give the building an improved insulation or R-Value to the roof.

However, due to the thin nature of the coating on the walls it would not be significant. Possibly the greatest change that the structure will experience with this new coating is that it has become waterproof and vapor impermeable assembly. This means that rainwater or water vapor will have a difficult time penetrating the building. This can be either a good thing or bad thing depending on the mechanical systems performance inside the building which we will discuss more in the Mechanical Systems section of this report.

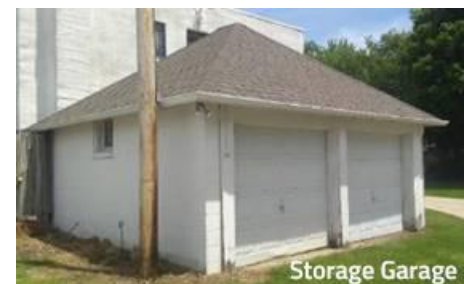
The exterior of the Storage Garage south of the Jail appears to be in good shape. The concrete block showed minimal signs of cracking and movement and the painted exterior coating is in pretty good condition. It is an unheated space used for general storage. There are older

wood windows on the garage that need reglazing minimally or replacement all together. The roof shingles were replaced at the same time as the Sheriffs Department Office and should last for another 20 years if not unusually damaged. The wood trim around the overhead doors have started rotting where they touch the ground and could warrant replacement or repairs.

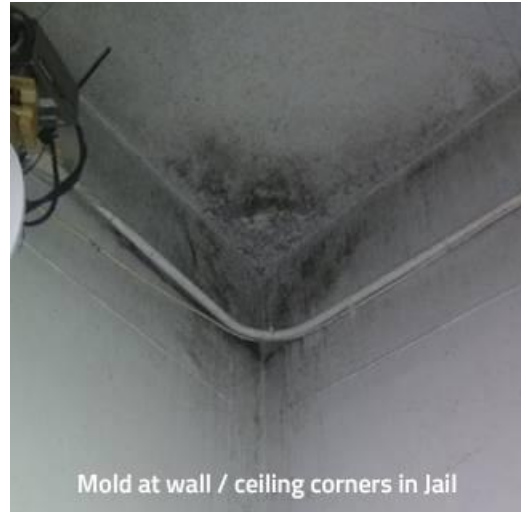
At a number of locations throughout the Jail you can see mold developing on the wall and ceiling surfaces. This is an issue that has been reported in nearly every Jail Inspection Report from the last 10 years. This problem is likely due to a combination of HVAC units being undersized, insufficient air circulation, and the sprayfoam/waterproof coating on the exterior of the building preventing any transfer of water vapor through the building assembly. Additionally, mold can thrive by condensation forming on the walls due to

high levels of temperature/humidity levels between the interior and exterior. Corners of walls and ceilings, like the photo on the previous page, provide the perfect location for mold to form as those are the pockets where the conditioned air is least able to reach and circulate which provides the stagnant air mold loves. Traditionally mass masonry buildings did not have vapor barriers and could safely transfer water vapor inside or outside depending on where the vapor drive was migrating. This mold requires staff to constantly clean and sanitize surfaces in an effort to provide a healthy environment. According to the Centers for Disease Control (CDC), mold can seriously affect individuals with respiratory or immune system problems. It can also negatively affect normally healthy individuals.

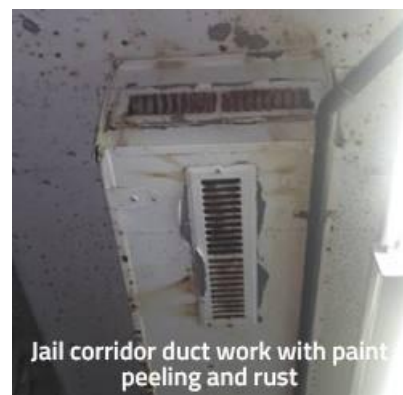
The ductwork throughout the Jail is mostly original. Most of the ductwork is exposed to the inmates and have been damaged on occasion. Due to the low ceiling heights in the Jail, it is not very feasible to reroute or conceal the ductwork to keep it out of reach of inmates so it will likely continue to be a safety/security problem.

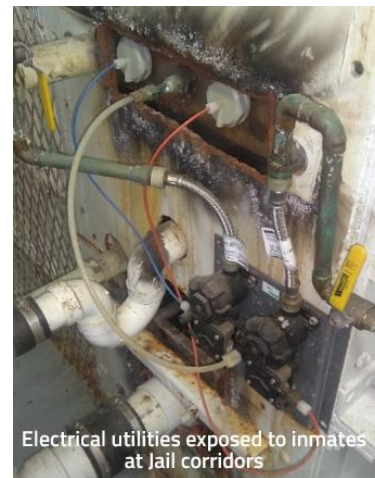
Throughout the Jail, there is exposed electrical conduit and lines which are readily accessible to inmates. There was a wire mesh welded to the steel bars in an effort to prevent inmates from tampering with the electrical systems however the inmates would then work to pry off sections of the wire mesh and create weapons out of it. Due to the physical layout of the Jail, it is not feasible to move the conduit and wires because there is limited space in the narrow hallways, with open cells to the hallway.

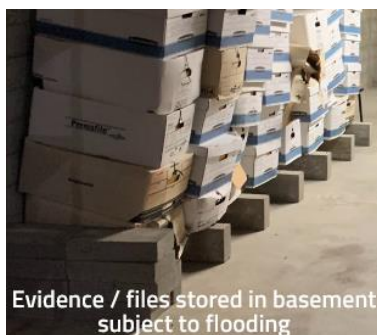
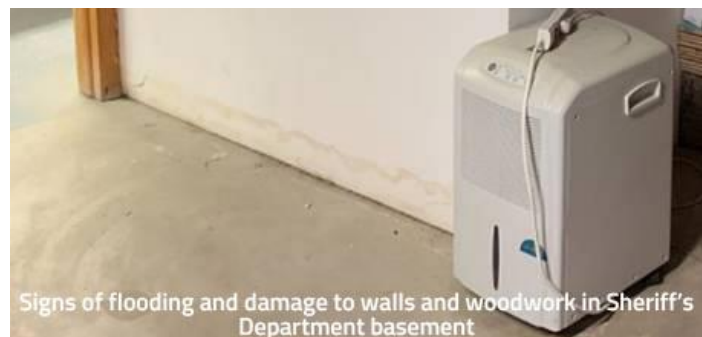
On the plumbing side, one of the first issues noticed is that the basement of the Sheriff's Department Office has experienced flooding on a number of occasions. Sheriff staff have determined that the issue is caused by a City of Clarinda storm drain lines being tied into the sewer lines which then causes the flooding. It is evident on the walls, doors, furnishings and other elements that the flooding has occurred a number of times and is causing damage to those elements.

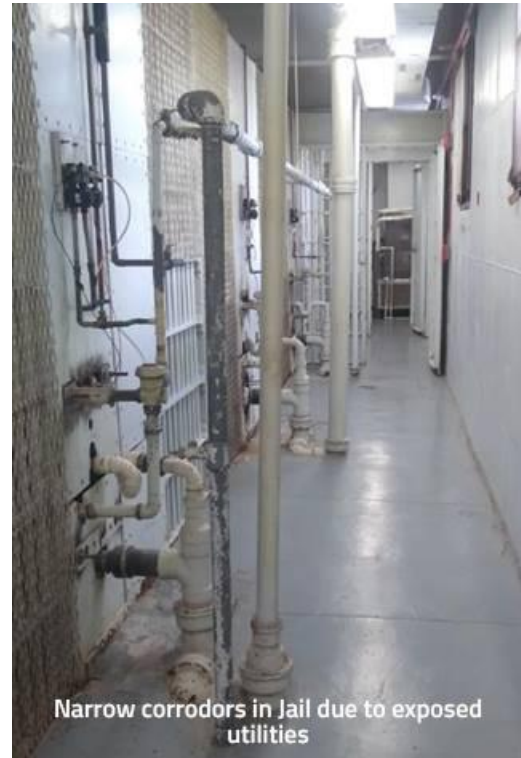
In the cell areas of the Jail, there are very minimal floor drains to take on water from leaks, messes and regular cleaning activities. Along with only a few floor drains, there are limited drain shutoffs which help to prevent backups to the drainage system when inmates put items in the drains or other build up occurs. This has led to temporarily unsanitary conditions for the inmates. Most of the drain lines are original cast iron lines which show signs of rust and degradation. These drain lines are often exposed in the corridors where inmates are moved through and accessible to inmates in the cells at locations. Due to the construction of the facility, it would be costly and very disruptive to daily operations of the Jail to add additional and proper floor drains. Many of the P-

Narrow corridors in Jail due to exposed utilities

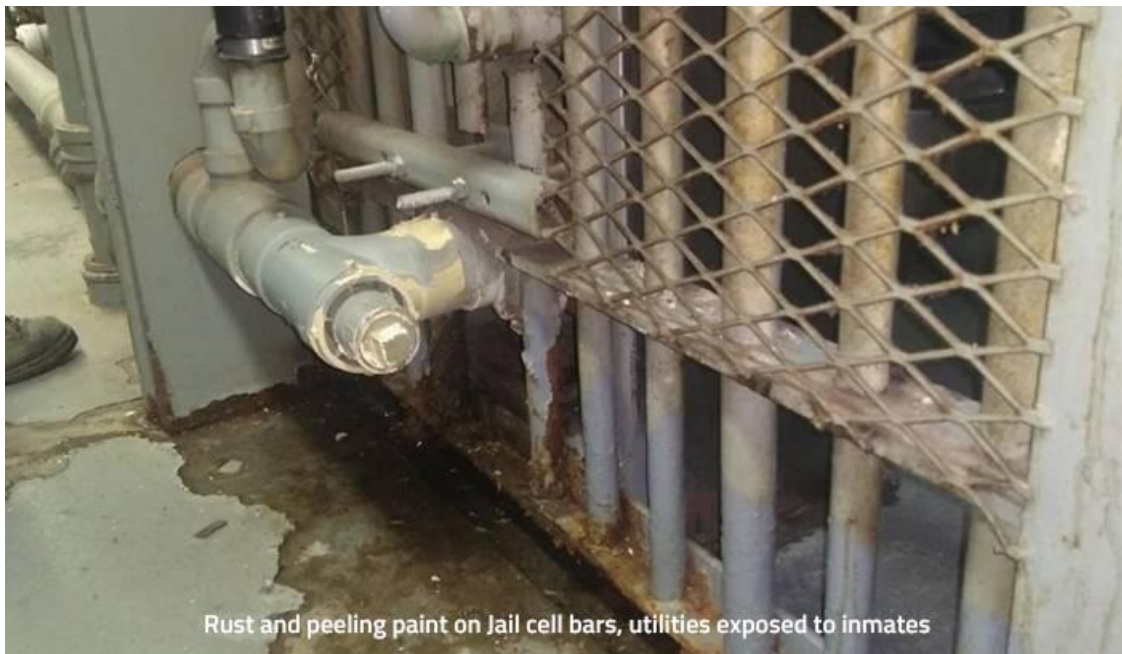
Traps are cast within the concrete floors so they are not readily accessible for repairs or cleaning. Many of the plumbing lines have paint peeling due to the rust forming from excessive moisture and leaks.

Rust and peeling paint on Jail cell bars, utilities exposed to inmates

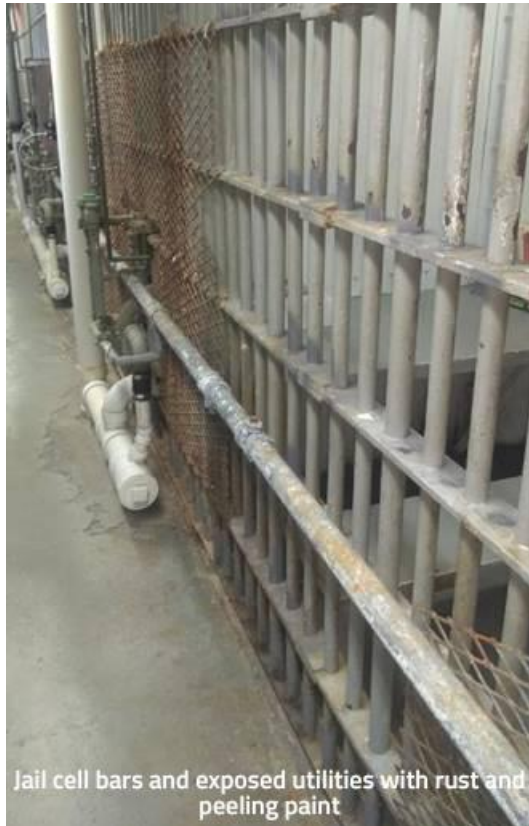
Many of the water supply lines are also original to the building and exposed in corridors and are able to be tampered with at some locations by the inmates. The supply lines also show signs of deterioration.

Jail cell bars and exposed utilities with rust and peeling paint

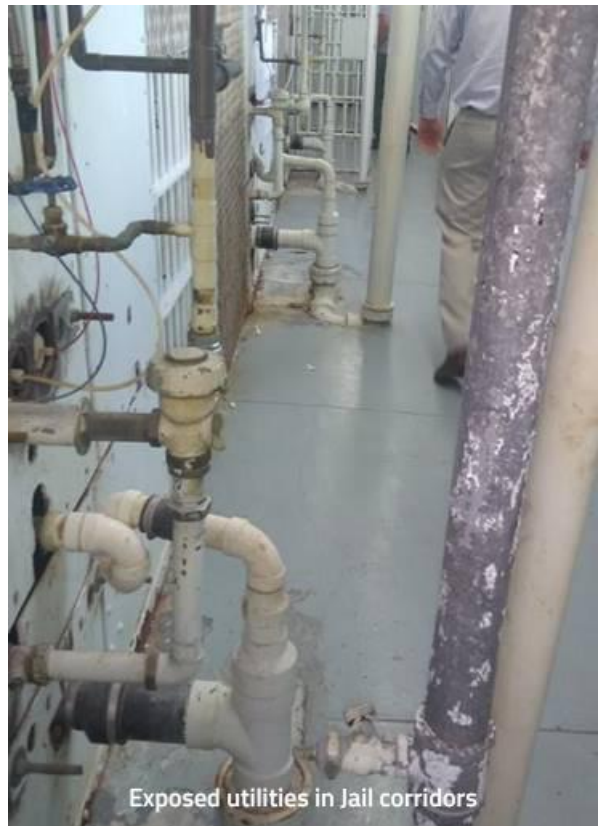
Exposed utilities in Jail corridors

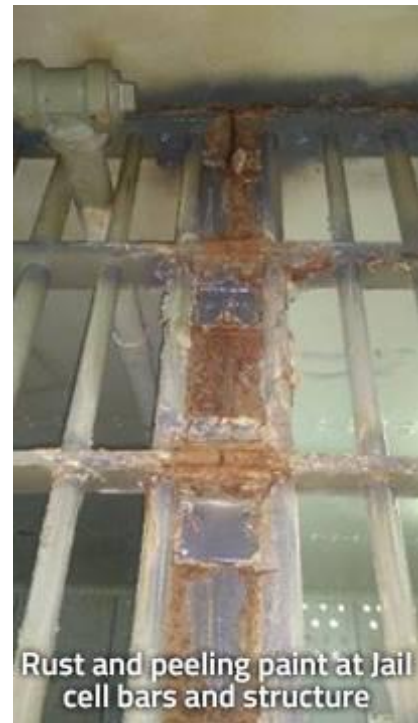
The Jail's cells are primarily constructed from steel bars and welded wire mesh that was added later to prevent inmates from tampering with the building utilities and reaching out as others walked in the narrow corridors surrounding the cells. These steel bars show significant signs of rust and peeling paint which can pose health problems. This rust/peeling issue is due to water leaks, moisture problems and corrosion from contact with the concrete structure. It is quite likely due to the age of the building, that much of the paint throughout this area is lead based paint which is known to pose health problems. Attempts have been made to repair and repaint the steel only for it to peel and rust again shortly after. There have been many instances where cells have not been able to be used due to the problems with rust, peeling paint, and the buildings mechanical.

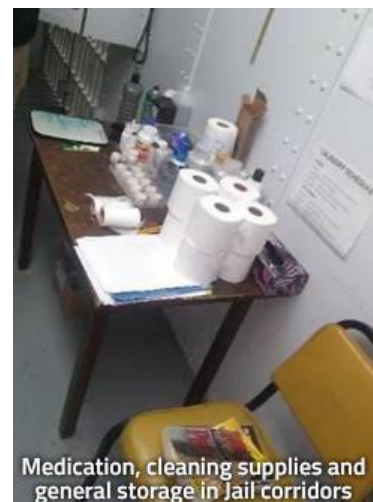
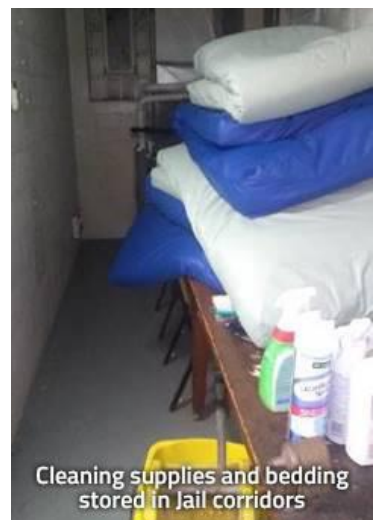
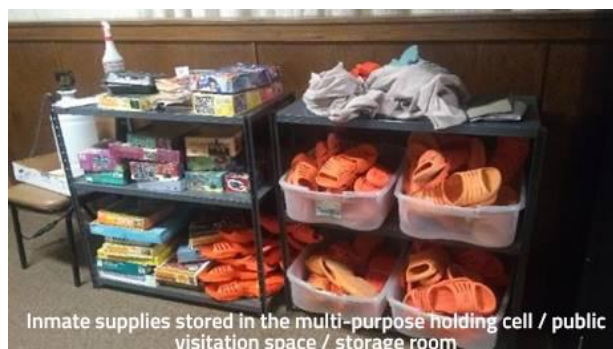
Throughout the facility there is a lack of proper storage spaces, whether for the Jail or Sheriff's Department. Inmate storage is primarily handled with metal lockers located in the same space as the public visitation and holding cells. Another example of the facility not having proper storage spaces is that there are many places next to the cells, on tables, in the stairways, in the shower and other places where they are used for storage of cleaning supplies, chemicals and other items that inmates have easy access to and should be kept in separate locked rooms or cabinets. The staff simply does not have sufficient space to securely store items. The images below and to the right show items that are in stored in the visitation room, or next to the cells / dorms.

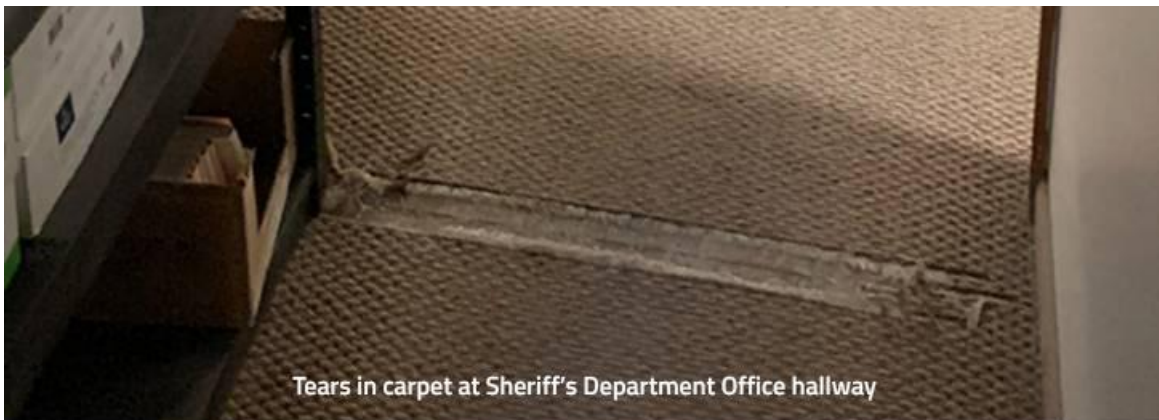
The Sheriff's Department Office has a mix of broadloom carpet and vinyl flooring. In most places the flooring itself is in fair condition. There are a few locations where the carpet has been ripped/torn as shown in the image below. The transitions between various floors are handled with metal transition strips.
