**PAGE COUNTY  
JAIL STUDY  
OCTOBER 19, 2021**

## INTRODUCTION

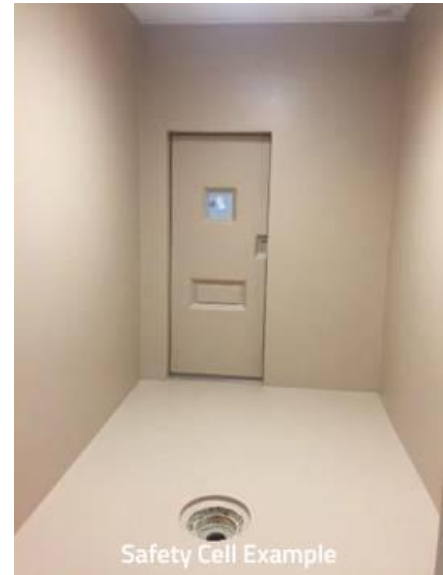
The existing facility does not have a safety (padded) cell similar to the example image to the right. Additionally, the existing Jail does not have the ability to have a proper medical isolation or quarantine cell. These types of safety or isolation cells are becoming more important to jails as mental health problems become more common. Mental health is expected to become a much greater problem for the Page County Sheriff's Department and Jail due to the recent reduction in funding for mental health facilities in Iowa. When hospitals or other mental health facilities are not able to treat the individuals, they often end up in Jail. These types of cells help to protect the inmate from injuring themselves and surrounding inmates and staff. The only tool Page County Jail Staff have at their disposal to help protect themselves and the inmate from injuring themselves is an old, modified restraint chair that is shown to the right.

Safety Cell Example

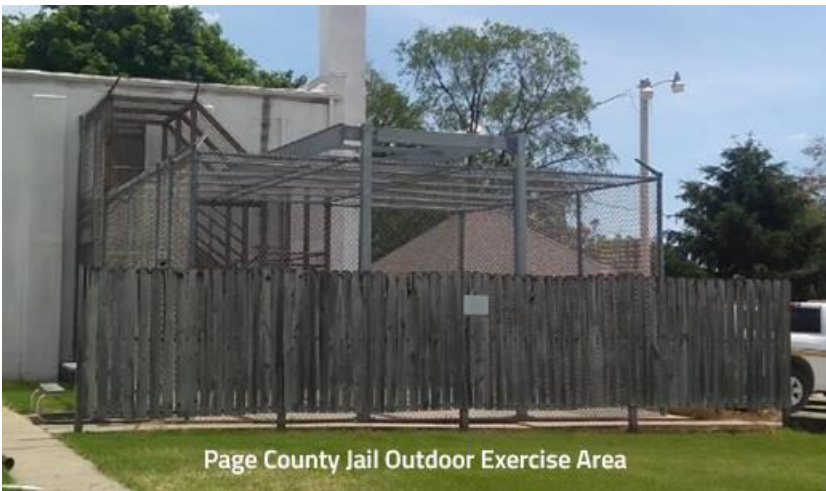
small exterior exercise area that is fenced in on the west side of the facility. Two inmates have escaped from this exercise area in recent years because they were able to climb between the joints of the chain-link fence. There is a wooden privacy fence to prevent views to and from

inmates, as well as to prevent them from exposing themselves to the public. There have been many studies which show that inmates who have access to activities and programs during their sentence, typically have a lower recidivism rate and are less disruptive while incarcerated.

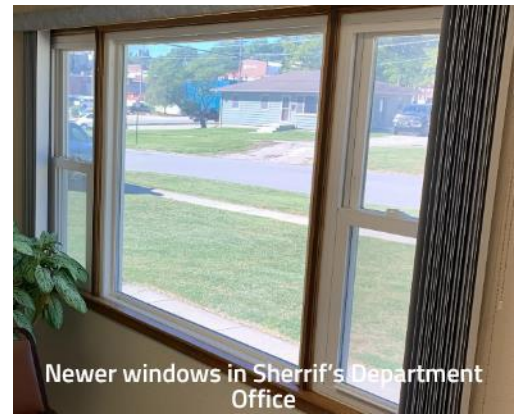
The Sheriff's Department Office area has newer double pane vinyl windows with insect screens which appear to be in very good condition. There is a mix of double hung and fixed windows. Some of the double hung windows are sized such that they could be used as an egress window if needed. Most decent quality vinyl windows have a life expectancy of 20 to 40 years depending on quality and abuse.

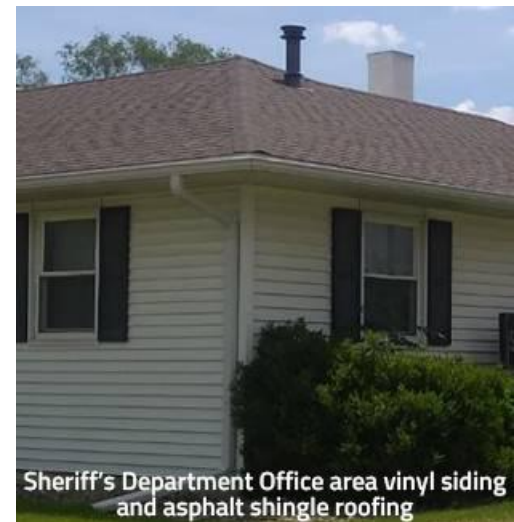
The exterior of the Sheriff's Department Office area appears to be in good condition. The vinyl siding is in good shape and should last the life of the building as long as it is not damaged. The asphalt shingles on the roof appeared to be fairly new, so it is probable that they should last another 20 years without unusual abuse.

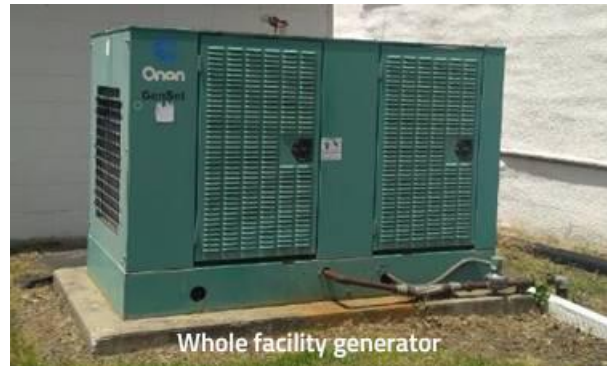
There is a 45KW natural gas generator in the southeast corner of the Garage / Jail that is sized to power the entire building in the event of a power outage. This generator is tested regularly and appears to be in good condition.

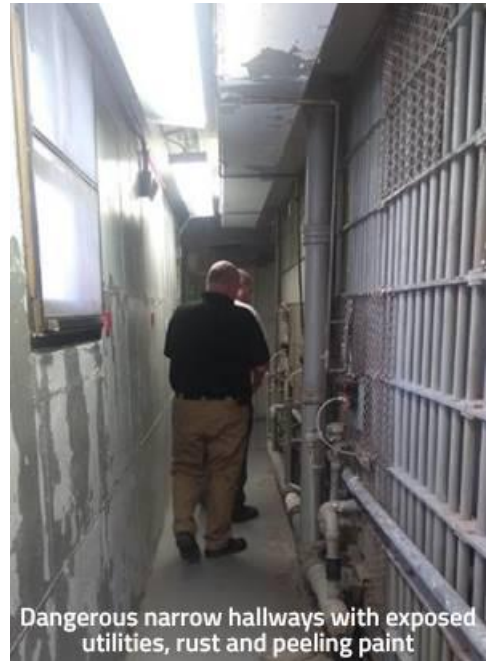
The mold and rust issues that are present throughout many areas of the Jail and cellblocks is likely to be a problem that will not go away without major renovations and modifications to the jail.
